## V-P shunt calcification

**DOI:** 10.1594/EURORAD/CASE.14594

**Authors:** Dr. Abeer Ahmed Alhelali<sup>1</sup>, Dr. Nitin Airon<sup>2</sup>

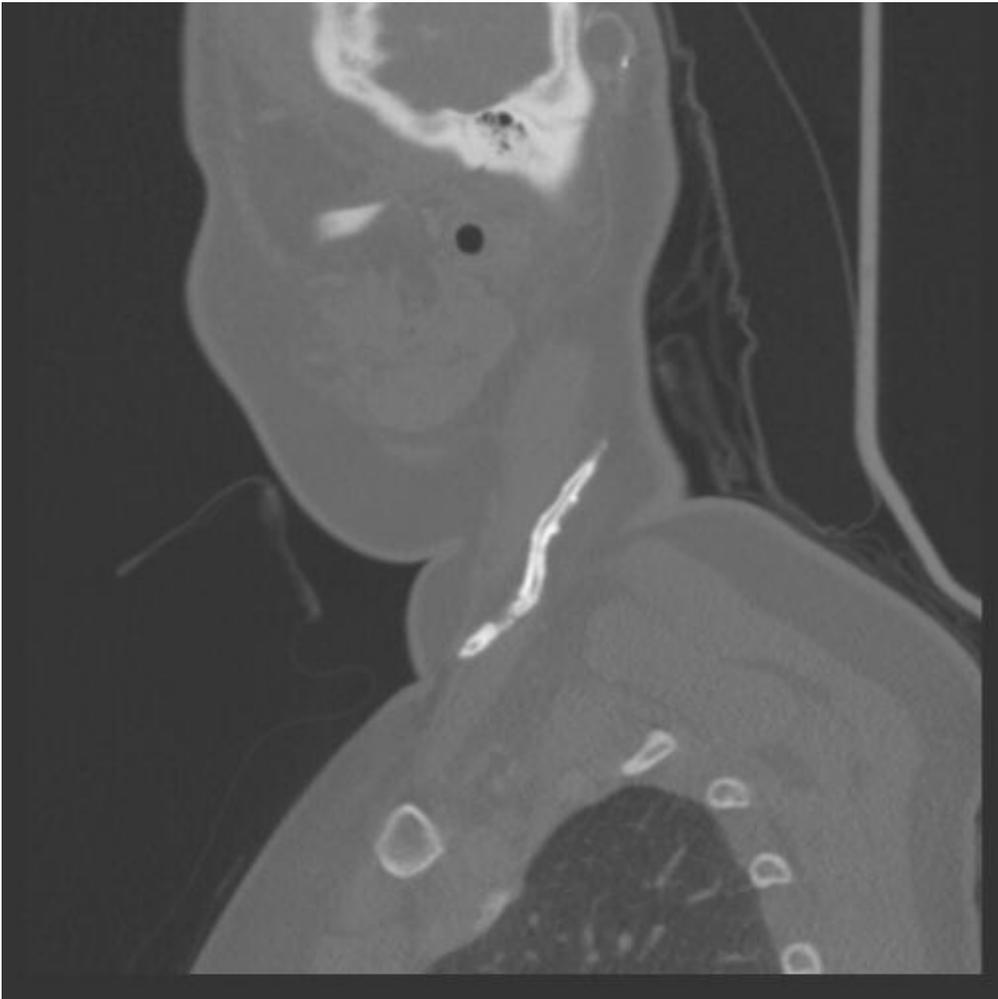
**Figure 1**

CT soft tissue neck showed thickening of the V-P shunt catheter in the cervical region, starting at the level of C3-4 intervertebral disc and extending up to C7 vertebral level.

This focal thickening is secondary to irregular calcification surrounding the course of the shunt catheter. No obvious breakage or discontinuity was noted in the visualised part of the V-P shunt.

**Description:** Irregular calcification surrounding the course of the VP shunt catheter in the right lower lateral neck, appearing as a thickened shunt tube. **Origin:** Sheikh Khalifa medical city. Abu Dhabi, UAE.

Management of VP shunt calcification is removal of the old catheter and subsequent shunt replacement [2].

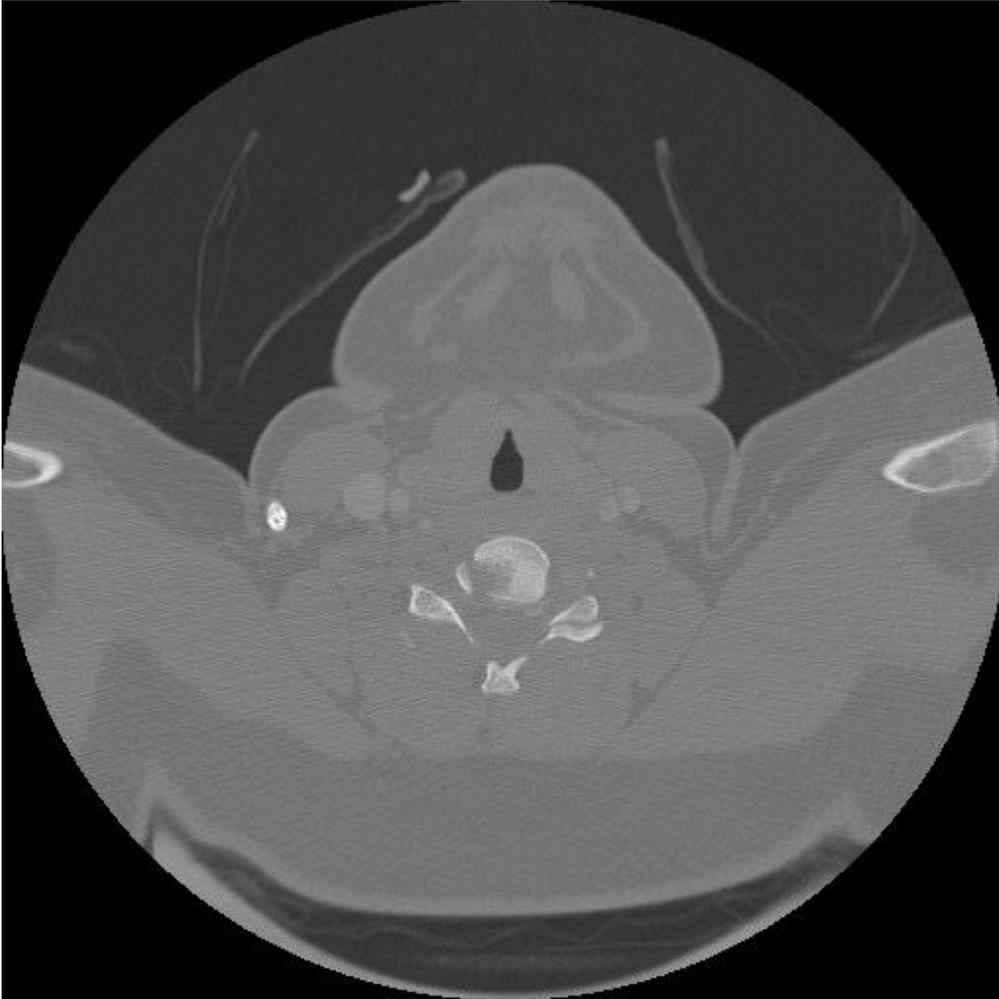
**Figure 2**

**Description:** Irregular calcification surrounding the course of VP shunt catheter in the right lower lateral neck, appearing as a thickened shunt tube. **Origin:** Sheikh Khalifa Medical City. Abu Dhabi, UAE.

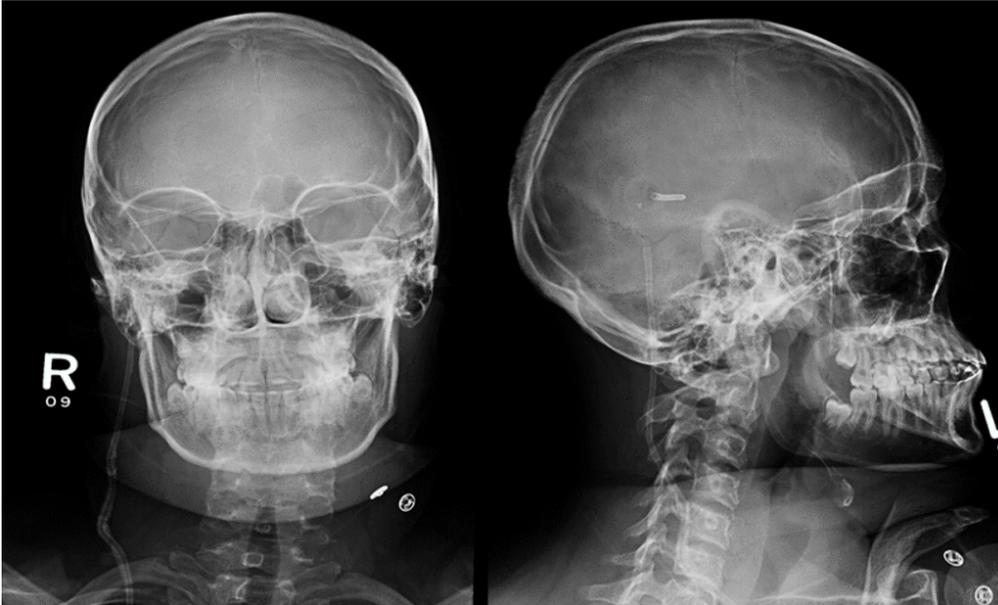
## Figure 3

Shunt series radiographs showed a right-sided V-P shunt with no evidence of breakage; however, irregular thickening was noted in the lower cervical region.

**Description:** Head and neck AP and lateral radiographs demonstrate a right-sided V-P shunt with no evidence of breakage. However, irregular thickening is noted in the lower cervical region. **Origin:** Sheikh Khalifa Medical City. Abu Dhabi, UAE.

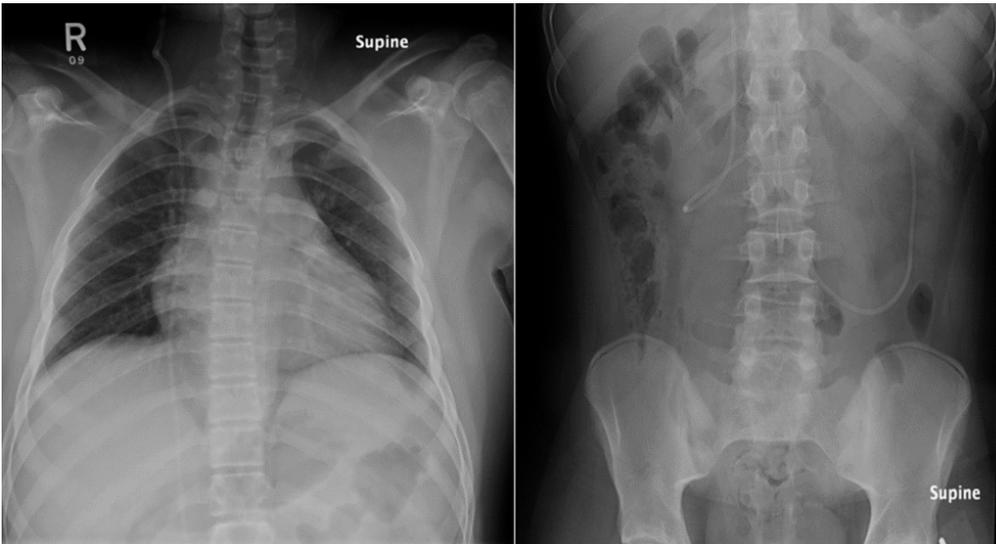
**Description:** Chest and abdominal radiographs partially visualise the VP shunt overlapping the right hemithorax and abdomen with no evidence of calcification or discontinuity. **Origin:** Sheikh Khalifa Medical City. Abu Dhabi, UAE.
