Case 790

Sigmoid volvulus in a young adult

Section: Abdominal imaging Imaging Technique: MR Case Type: Clinical Cases

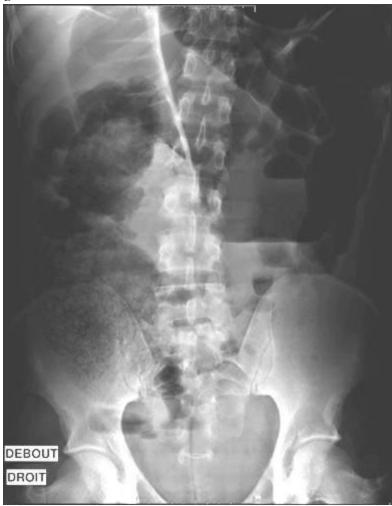
Figure 1

Description: Upright. Multiple air-fluid levels in the left lower quadrant and pelvis. Presence of abundant stool in the caecum. Empty rectum. Empty left lower fossa. **Origin:**

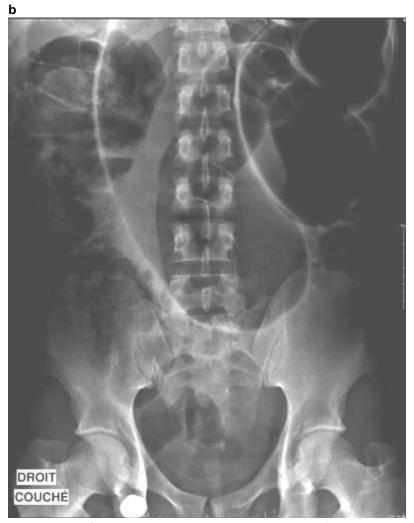
Description: Supine. The "coffee bean" sign is visible (close apposition of the sigmoid loops) Origin:

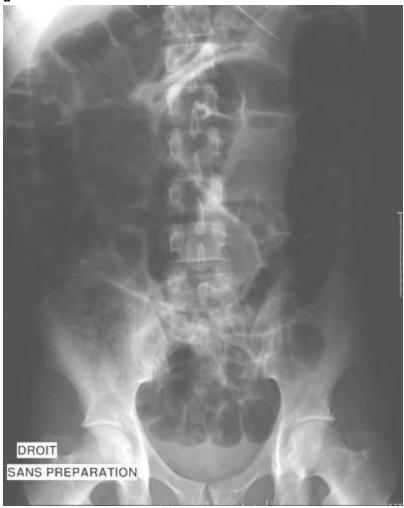
Figure 2

Description: The Northern exposure sign is visible because distension of the transverse colon had increased. **Origin:**

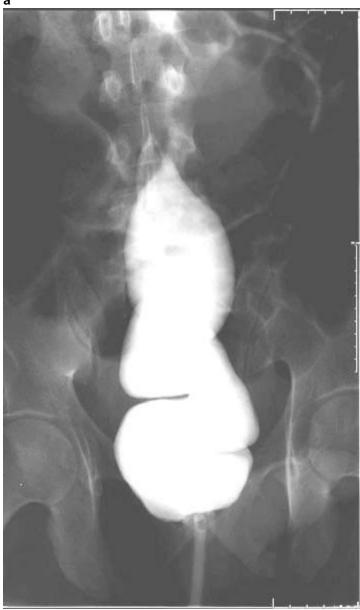
Figure 3

Description: AP view. Typical bird's beak image at the obstruction site **Origin:**

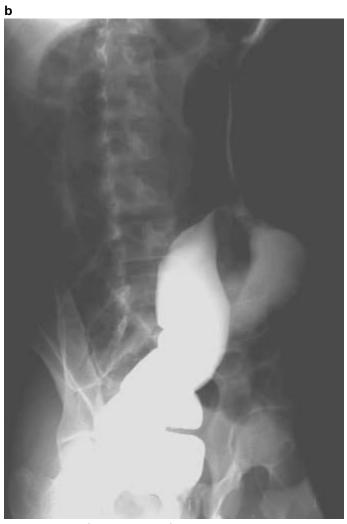
Description: Oblique view. Contrast medium visible through and above the obstruction **Origin:**
